ATKISON INSPECTION SERVICE, INC

Building Inspection Report

2748 W. California Drive, Chandler, AZ

Report Number:
131201

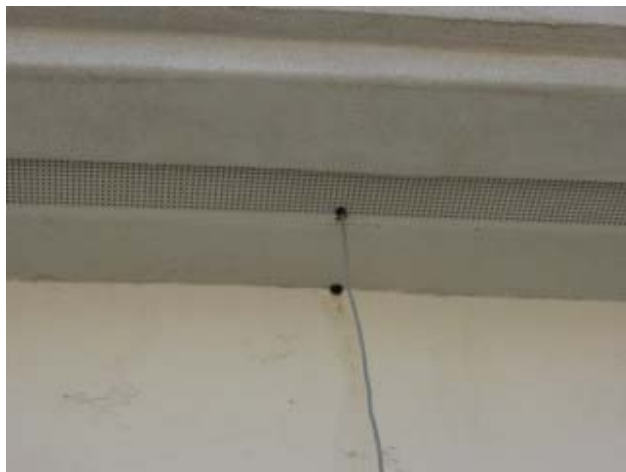
Picture 1: Holes in soffit east side of house.

5. **Repair:** The holes in the stucco finish coating on the soffit above the main electric service panel should be filled in order to prevent access to the attic by bees. Please refer to picture one in this report for additional information.

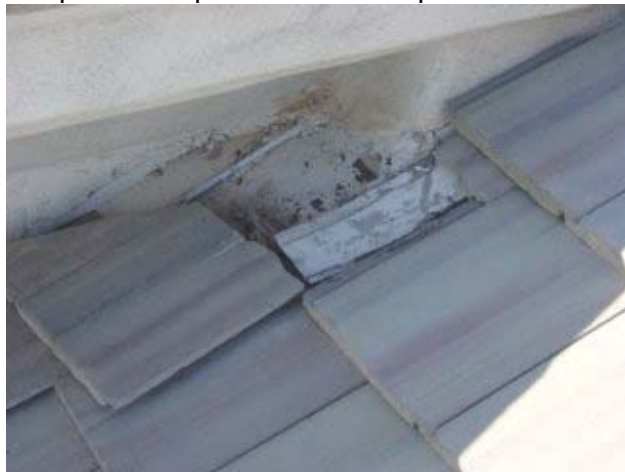
Picture 4: Tile slipped out of position, east side of covered entry.

3. **Repair:** One of the roofing tiles at the wall on the east side of the covered entry has not been properly secured into place and has therefore slid out of position. Repair is needed. Please refer to picture four in this report for additional information.

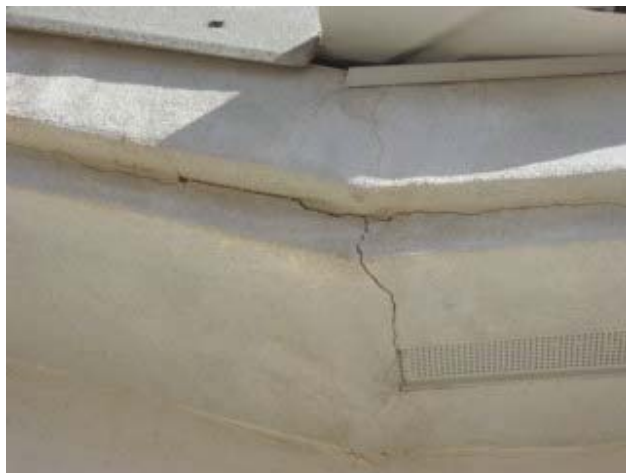
Picture 2: Cracks in stucco on soffit west side.

4. **Repair:** The cracks in the stucco finish coating on the soffits under the valleys on both sides of the house need to be repaired by a qualified licensed contractor. The lack of attention will result in additional damage and storm water penetration. Please refer to picture two in this report for additional information.

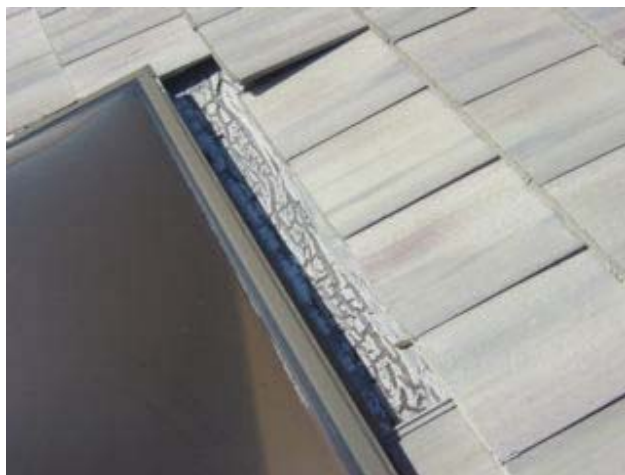
Picture 5: Reseal seam above skylight.

5. **Repair:** The edge of the membrane under the roofing tiles has not been covered with tile where it meets and has been sealed to the skylight flashing. The asphalt material at this seam has therefore deteriorated due to exposure to the sun. This seam should be resealed and covered with tile in order to prevent additional damage. Please refer to picture five in this report for additional information.

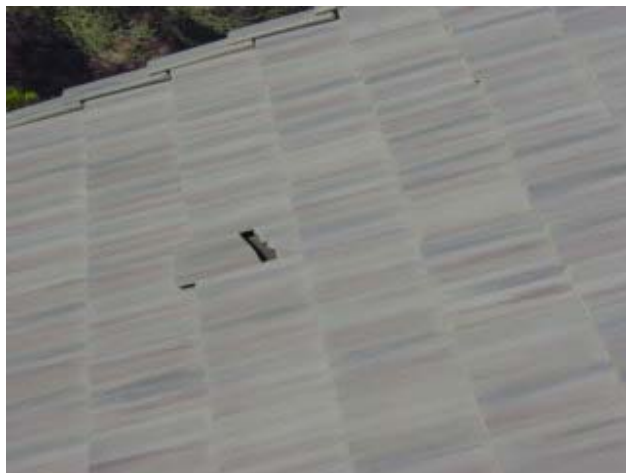
Picture 3: Example of broken tiles.

1. **Repair:** At least twelve broken roofing tiles were found on the roof and marked with yellow Xs for easy identification. Broken tiles allow the felt underlayment to be exposed to damaging ultraviolet sun light and storm water penetration. A qualified licensed roofing contractor should be engaged to replace the damaged tiles and to evaluate and, repair as needed, the membrane roofing under the damaged tiles. Please refer to pictures three and seven in this report for additional information.

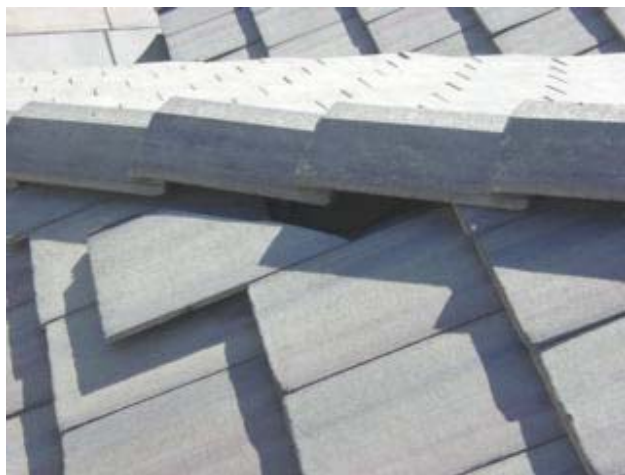
Picture 6: Example of tile slipped at hip.

2. **Repair:** A few cut field tiles at the hip cap tiles on the garage roof have slipped out of position because there were not properly secured into place. Tiles that are out of position allow the felt underlayment to be exposed to damaging ultraviolet sun light and storm water penetration. Repairs, by a qualified licensed roofing contractor, are needed. The membrane roofing exposed while the tiles where out of place should be evaluated and repaired if needed before the tiles are re-secured into place. Please refer to picture six in this report for additional information.

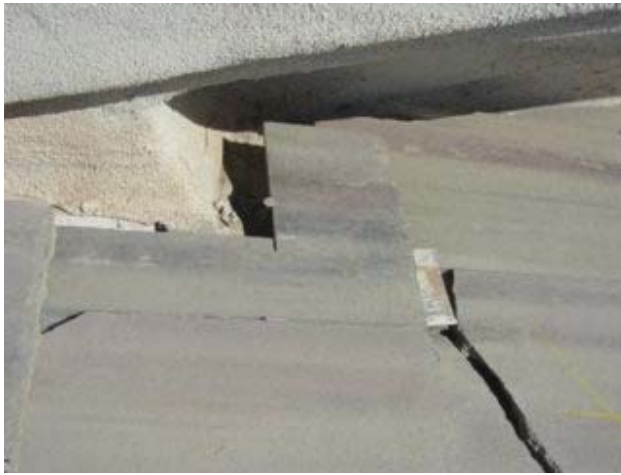
Picture 7: Poor transition between tile and wall west side of entry.

4. **Repair:** No flashing has been installed above the roofing tile at the jog in the wall on the west side of the covered entry. This is allowing storm water penetration under the roofing tiles. Repair is needed. The same type of flashing will also need to be added where the tile has slipped out of position on the east side of the entry. Please refer to picture seven in this report for additional information.

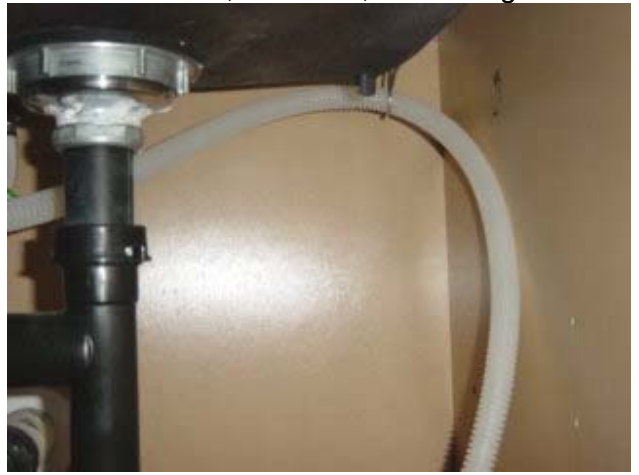
Picture 9: Waste drain hose from the dishwasher.

1. **Repair, Safety Issue:** The waste drain hose from the dishwasher does not loop properly above the bottom of the kitchen sink. This is needed in order to avoid back-drainage of dirty water from the sink and disposer to the dishwasher. Please refer to picture nine in this report for additional information.

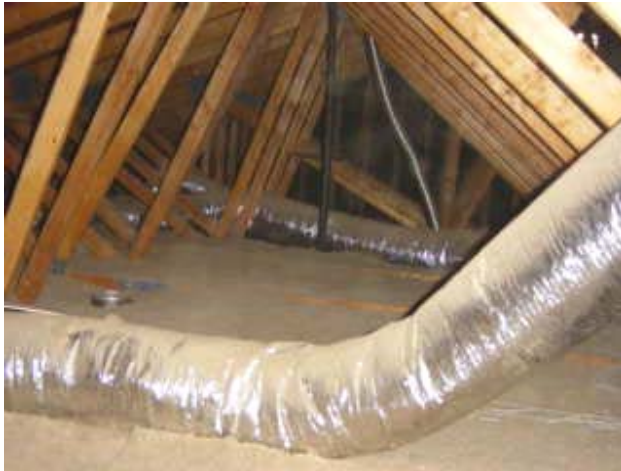
Picture 8: Ducts not hanging from trusses.

1. **Repair:** The flex ducts inside the attic have not been properly installed. These ducts should be hung from the trusses so that they flow directly into the ceiling registers without sagging or sharp bends. The proper installation of the ducts will improve the efficiency of the air flow through the heating/air conditioning system. These repairs should be completed by a qualified licensed heating/air conditioning contractor. Please refer to picture eight in this report for additional information.

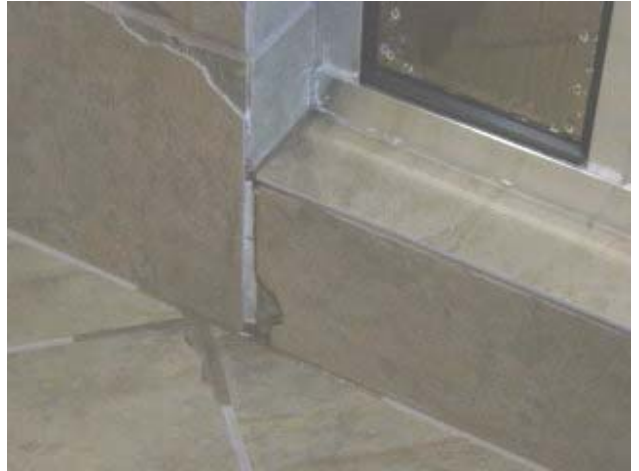
Picture 10: Leak base of master shower.

1. **Repair:** The bottom of the glass surround wall in the master bathroom shower needs to be re-sealed in order to prevent additional leaking concerns. Please refer to picture six in this report for additional information. Please refer to picture ten in this report for additional information.
2. **Repair:** One of the mirrored bypass closet doors in the exercise room is cracked. Replacement is needed.
3. **Improve:** Several kitchen cabinet doors are in need of adjustment.
4. **Improve:** Nail pops were noted in the ceiling of the breakfast room. This does not appear to be a structural concern. Cosmetic improvements may be needed on an elective basis.
5. **Note:** The doors have been removed from the office and master bedroom.
