Building Inspection Report

9000 E. Fairmount Avenue, Scottsdale, AZ

Inspection Date:
June 1, 2007

Report Number:
50000

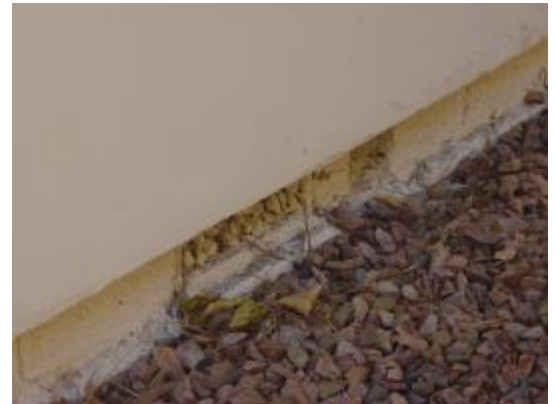
1. **Repair:** The plumbing pipes for the laundry room are exposed at the foundation under the exterior wall on the west side of the house. This portion of the foundation should be patched in order to protect the plumbing and to prevent insect/vermin access up into the wall.

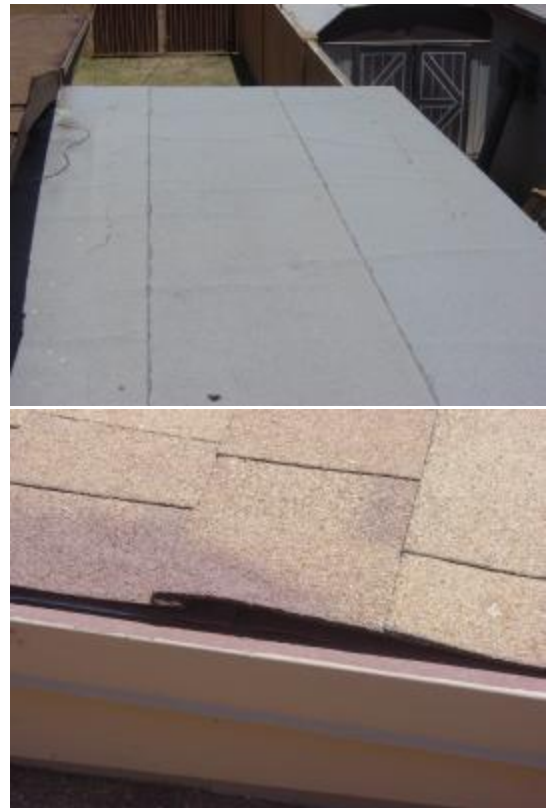
1. **Repair:** The roll roofing material on the east side patio/master bedroom closet roof is in poor condition. Roll roofing is not considered to be an acceptable type roofing material for a roof over a living space. This roofing material should be replaced with an appropriate type roofing material for the master bedroom closet.
2. **Repair:** The shingles on the roof over the back bedroom have not been properly secured into place around the edges. Evidence of lifting was noted on the sides and at the drip edge. Repairs are needed in order to keep the shingles from blowing off in a wind storm.

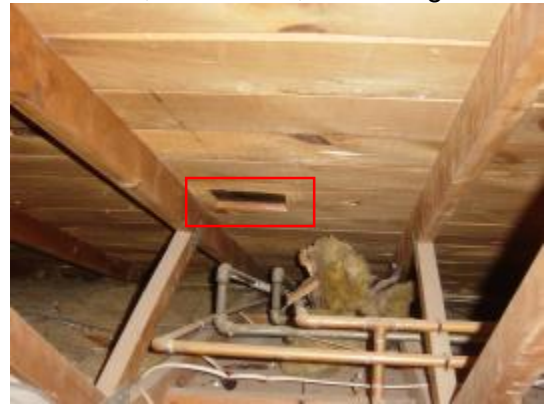
3. **Repair:** There are a few holes in the roof sheathing material visible from inside the attic. The back of the shingles was visible through these holes. Repairs are needed so that the shingles are not damaged by foot traffic. This could also be an unsafe condition if someone stepped through the hole.

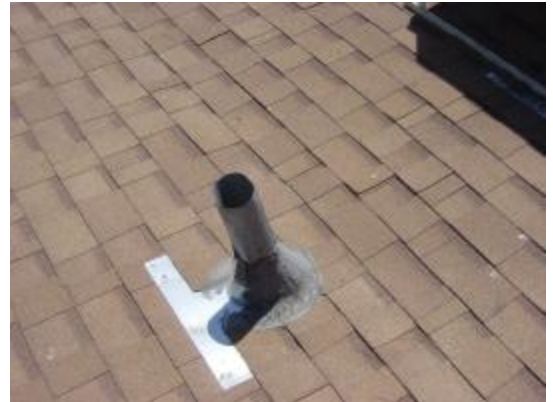
4. **Repair:** There is an exhaust vent pipe extending through the roof that is not capped or protected from rain. The end of this pipe can be properly shielded from rain and used as an exhaust vent location for the hall bathroom fan.

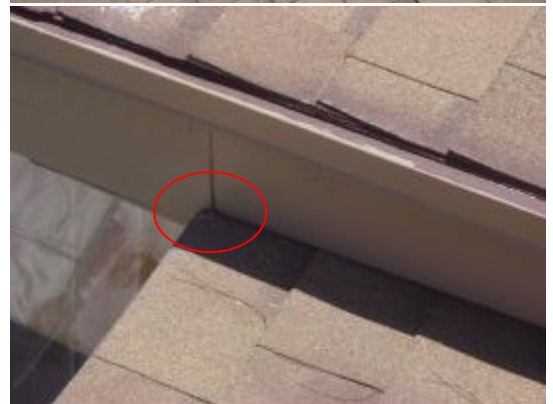
5. **Repair:** A kick-out flashing should be installed at the bottom of the metal flashing on the sloped roof over the kitchen where it connects with the gable rafter for the back bedroom roof. This kick-out flashing will divert storm water runoff away from the exterior wall and wood rafter cover where it will cause damage and leaking concerns.

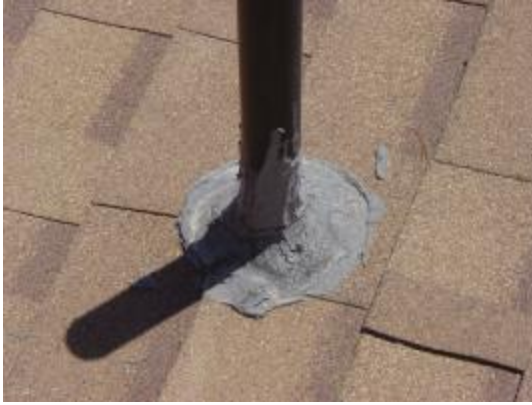
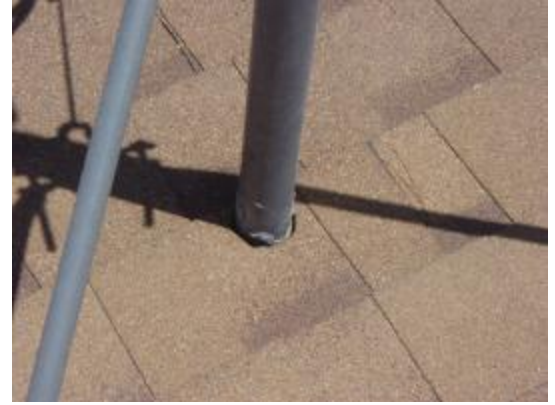
6. **Repair:** No flashing has been installed in the composition shingle roofing material on the roof around the some of the roof penetrations. Instead of flashing roof cement has been used. The seam around the main electric service drop conduit is open. Repair of that seam and yearly sealing of the sealed seams is therefore recommended in order to water penetration concerns. Evidence of prior water penetration was noted at some of these roof penetrations inside the attic.

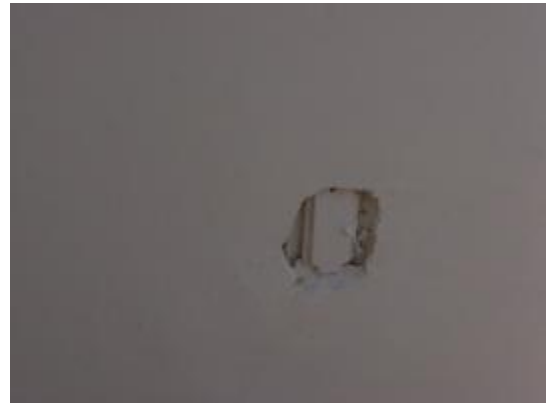
1. **Repair:** The stucco finish coating has been installed over the edges of the electrical outlet face plates in the exterior walls. This stucco should be trimmed back so that the cover can be removed, an extension installed on the outlet box and the outlet and cover reinstalled on the surface of the stucco.

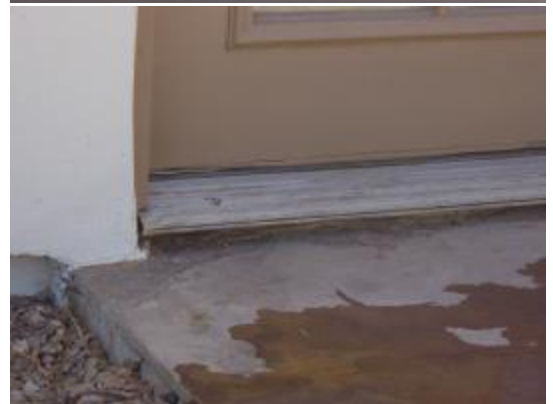
2. **Repair:** The threshold under the exterior door to the back patio has not been properly supported or sealed. Repairs are needed in order to prevent damage to the metal threshold and to prevent water penetration.

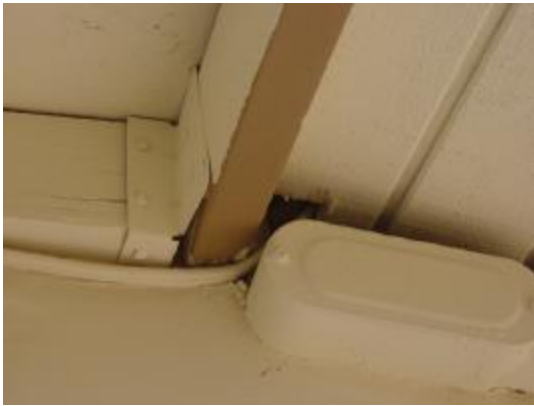
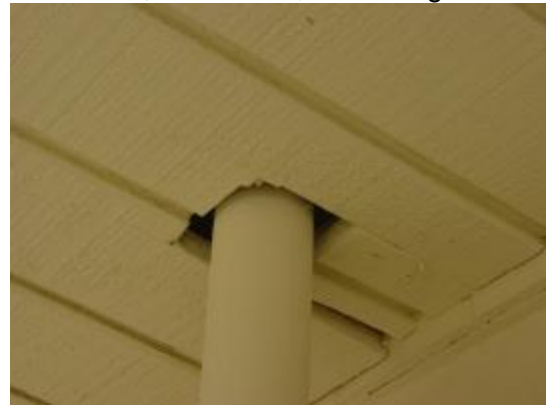
3. **Repair:** There are a few openings in the plywood soffit cover on the east side of the house. These openings should be covered in order to keep insects and vermin out of the attic.

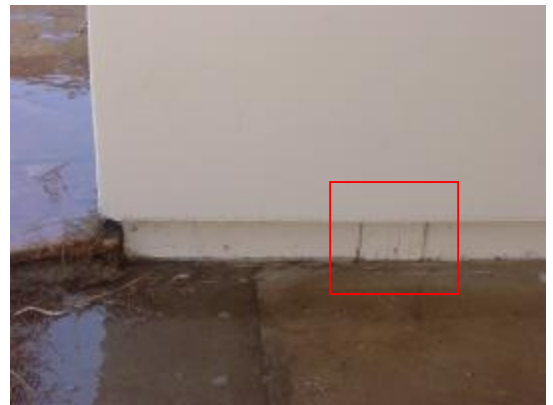
4. **Repair:** The bottom of one of the roof support posts in the exterior wall of the additional near the family room extends through the foundation to the old patio slab. This configuration exposes the bottom of this post to water runoff from the patio where moisture can be trapped around the post. This is a condition conducive to insect infestation and deterioration. Repair or improvement is recommended in order to avoid these concerns.

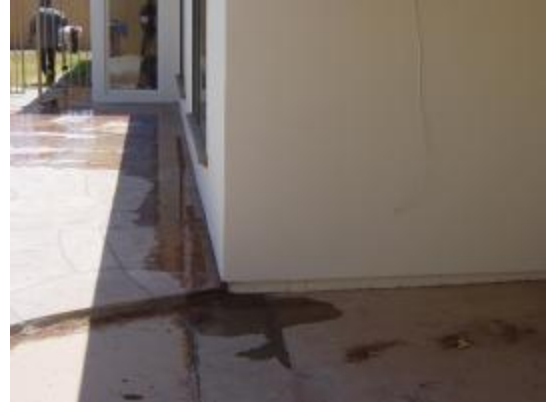
11. **Major Concern:** The flagstone back patio/pool deck slopes toward the exterior wall of the house. The stucco finish coating on this wall extends down to the flagstone. Storm water runoff and water from the pool and hosing off the patio runs against the bottom of the stucco wall while draining off the patio. Repairs are needed so that this drainage does not contact the bottom of the stucco wall system.

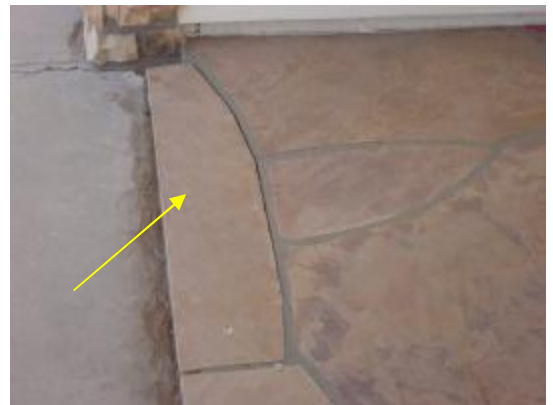
12. **Repair:** Improved drainage is needed out of the covered back patio slab on the west side of the back yard. Much of the drainage from the flagstone patio and pool deck runs across this patio where it ponds.
13. **Repair:** The grading all around the house should be improved to promote the flow of storm water away from the foundation. The grading in the west side yard should also provide drainage from the back yard to the front. The lack of attention could result in damage due to water-moisture penetration and/or settling concerns.
14. **Repair:** One of the pieces of flagstone at the front porch is loose. Repair is needed.

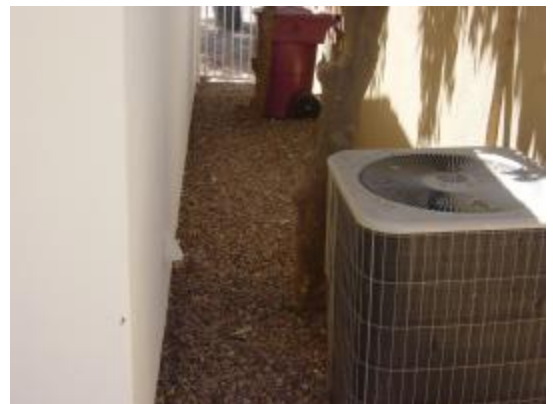
15. **Repair:** One of the wood slats is missing from the gate to the alley. Three of the boards have not been properly secured into place. Repairs are needed.
16. **Repair:** The air conditioning compressor being stored in the west side yard should be removed.

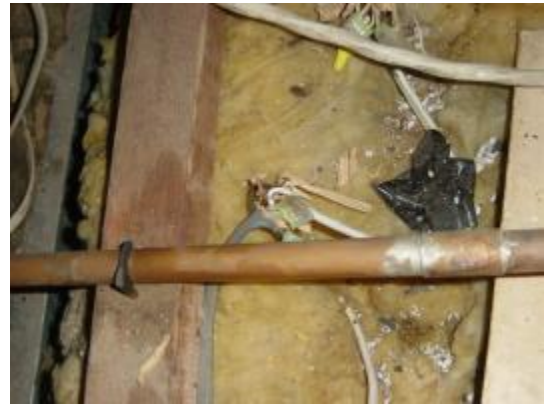
9. **Safety Issue, Repair:** The open electrical connections found throughout the attic should be enclosed in junction boxes that are fitted with cover plates. This will serve to protect the connections and to avoid an unsafe condition.

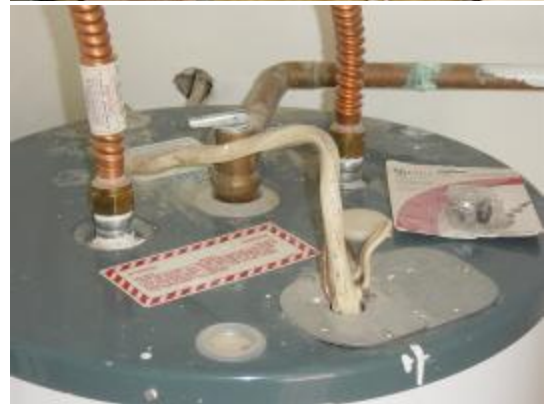
10. **Repair:** The electrical wire to the water heater should be installed in a protective conduit and protected with a grommet in order to prevent possible damage. An electrical disconnected switch should also be installed in the closet above the water heater. These repairs should be made by a qualified licensed electrician.

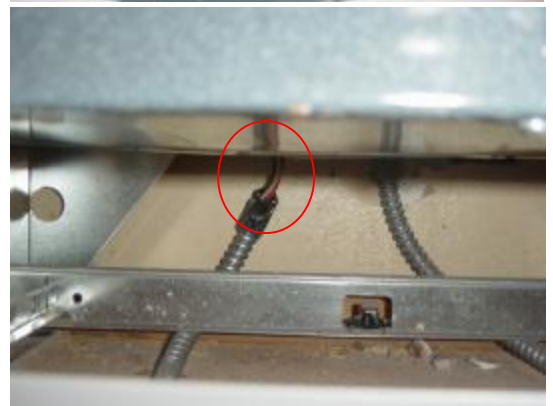
11. **Repair:** The electrical wiring for the range/oven has not been properly protected with conduit and is poorly positioned so that it keeps the drawer under the range from closing completely. Repairs are needed.

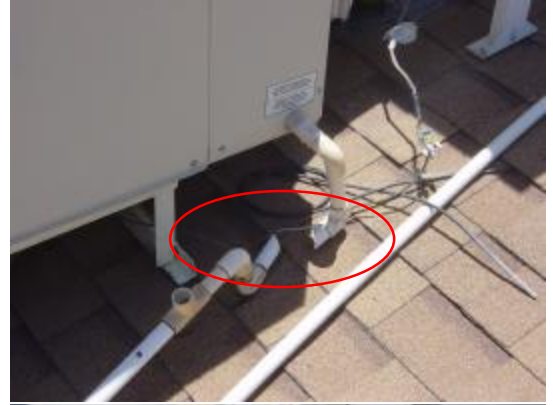
4. **Repair:** The condensate drain pipe from the heat pump unit on the roof is broken. Leakage from this pipe will cause eventual damage to the roofing materials. Repair is needed.

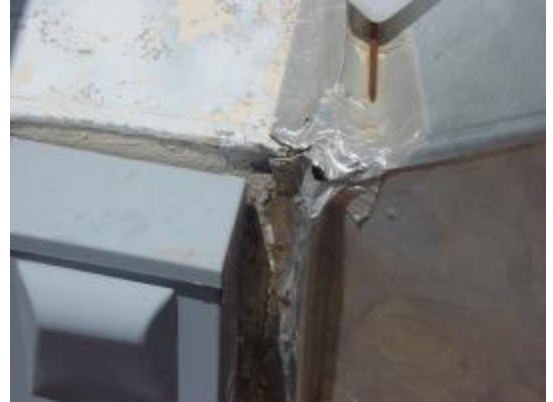
5. **Repair:** The seam between the heat pump unit and the metal air duct on the roof should be resealed. Cool conditioned air was escaping to the exterior during the inspection.

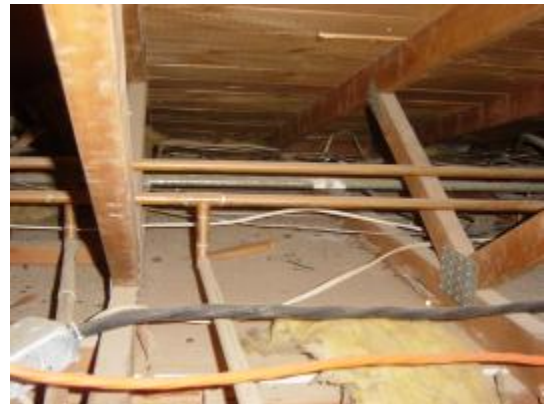
1. **Repair:** The insulation level through the visible portions of the attic is very low. Large portions of the attic, such as over the kitchen, are not insulated at all. Additional insulation should be blown into the attic once all of the repairs and improvements that require attic access have been made.

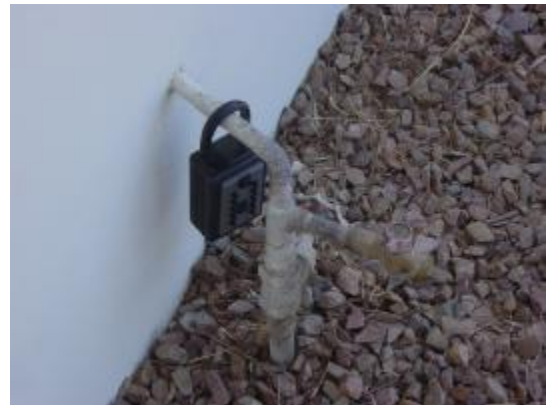
1. **Repair:** The main water supply pipe at the entrance in the front yard has been reduced to one-half (1/2) inch piping. This is severely restricting the water flow on the interior. The half inch pipe should be replaced with three-quarter inch piping.

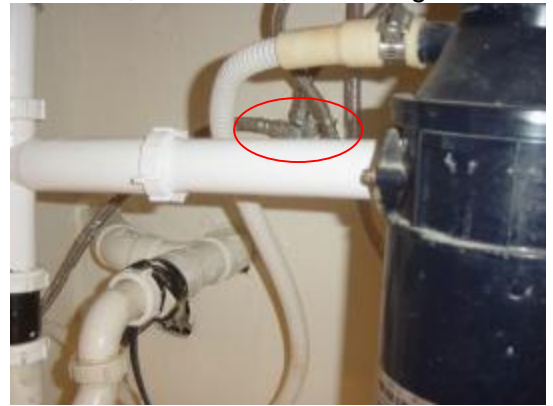
- Repair:** The handle is missing from the shut off valve for the hot water supply to the kitchen sink. This handle and possible the valve will need to be replaced in order to repair or replace the kitchen faucet.

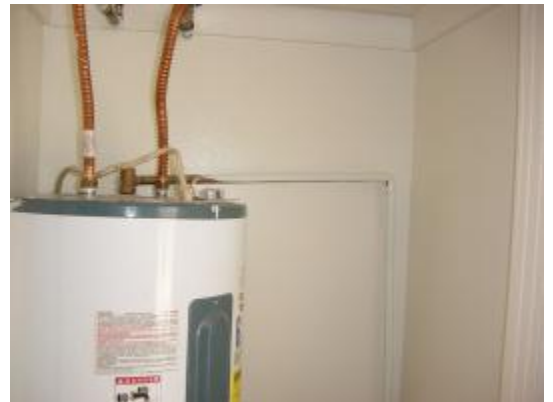
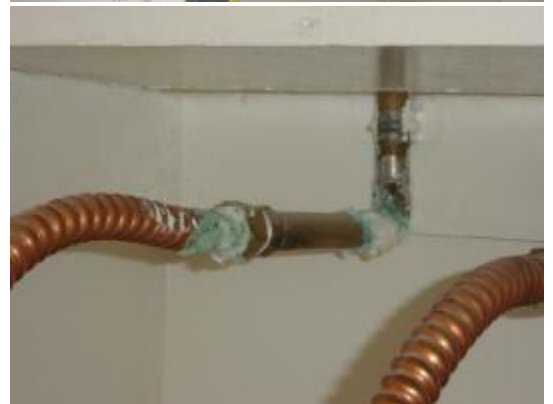
- Safety Issue, Repair:** The discharge piping serving the Temperature and Pressure Relief (TPR) valve for the water heater has been improperly installed. This pipe should slope along its entire length to allow drainage of water from the TPR valve. Repair is recommended to avoid an unsafe condition.
- Repair:** There is extensive corrosion on the water supply pipes above the water heater. This corrosion is a sign of slow leaking. Repairs are needed.

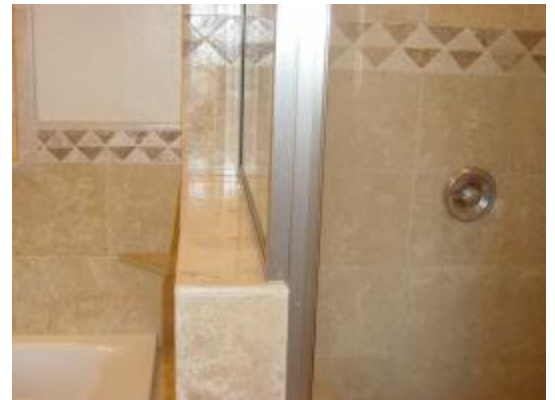
1. **Safety Issue, Repair:** The seam between the firebox inside the fireplace and the brick facing should be sealed with a heat resistant caulking in order to prevent a false chimney effect behind the brick. This is needed for safety concerns. The chimney sweep hired to clean the chimney can also seal this crack.
2. **Safety Issue, Repair:** The fireplace chimney should be cleaned and inspected by a chimney sweep prior to operation.
3. **Safety Issue, Improve:** The blades of the ceiling fan in the back bedroom are about six feet from the floor. Care is needed when the fan is running.
4. **Repair:** Water pours through the open seams in the master bathroom glass shower surround. Additional testing of the tile surround is recommended once the glass surrounds have been properly sealed.

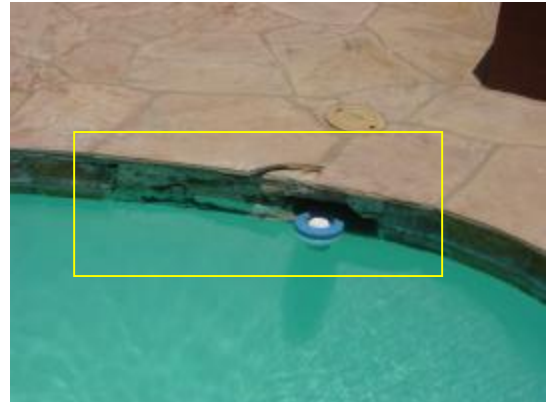
1. **Safety Issue, Repair:** The perimeter gates to the pool area should be equipped with self-closing and self-latching devices in order to help maintain a child safe barrier around the pool.
2. **Safety Issue, Repair:** Care is needed when using the pool while the pump is running. A person could be trapped by the suction of the pump at the single drain opening in the bottom of the pool. Children and persons with long hair are especially vulnerable. The installation of a floor drain cover designed to prevent this tragedy should be installed.
3. **Repair:** The flagstone water level tiles around the skimmer are missing. Replacements are needed.

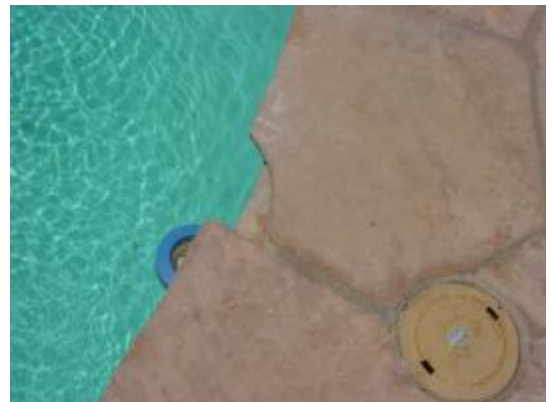
4. **Repair:** The pool decking flagstone at the skimmer is broken. Repair is needed.

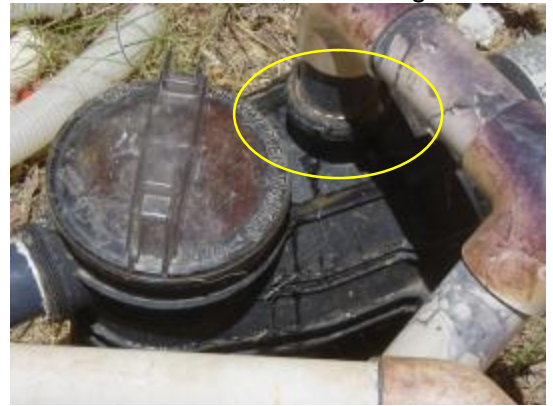
5. **Repair:** The plumbing connection to the top of the pool pump is leaking. Repair is needed.
6. **Repair:** The low water cut-off float device is missing from under the skimmer basket located in the pool deck. Replacement is needed to prevent air from being drawn into the system in the event that the water level gets too low.
