## Building Inspection Report

2100 N. Mesa Street, Mesa, AZ 85205

**Inspection Date:**  
June 6, 2012

**Report Number:**  
62000

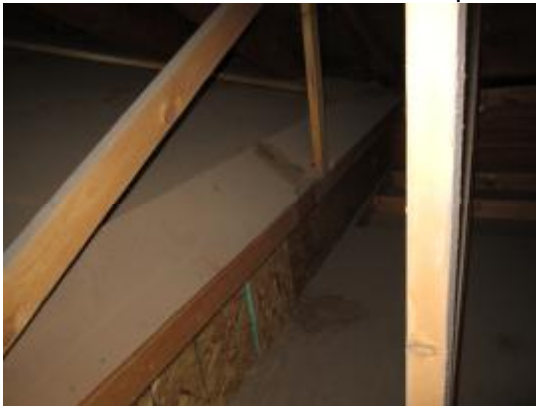
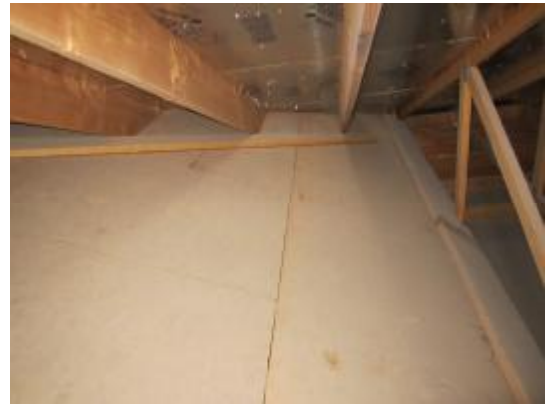
1. **Major Concern:** Several small stains were noted below the tile roof on the ceiling above the garage. These stains are due to roof leaks. Further evaluation of the tile roofing system by a qualified licensed roofing contractor is needed in order to determine the extent of repairs required. These stains were visible because there is no insulation on the ceiling above the garage. There could be additional leaking concerns on the remainder of the tile roof that could not be identified because the drips are landing in insulation and therefore not visible.

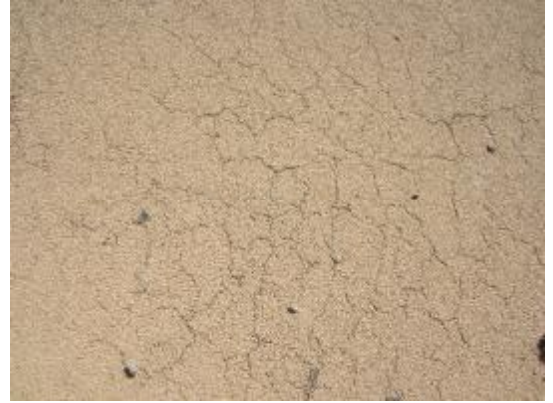
- 2. Repair:** Many small cracks are visible in the surface of the 90# cap sheet roofing material above the living room. While these cracks do not appear to represent a present leaking concern, they are an indication that the roofing material has reached the end of its serviceable life. Replacement is needed.

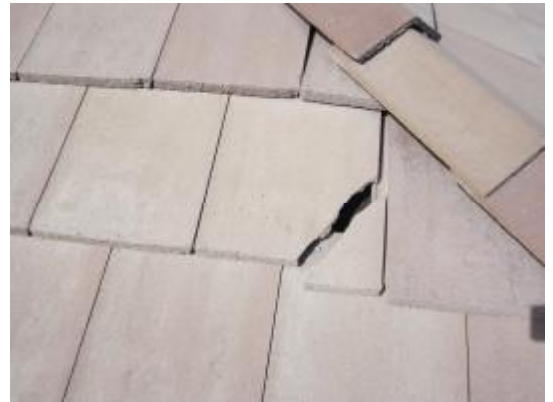
- 3. Repair:** Five (5) broken roofing tiles were found on the roof. Broken tiles allow the felt underlayment to be exposed to damaging ultraviolet sun light and storm water penetration. A qualified licensed roofing contractor should be engaged to replace the damaged tiles and to evaluate and, repair as needed, the membrane roofing under the damaged tiles.

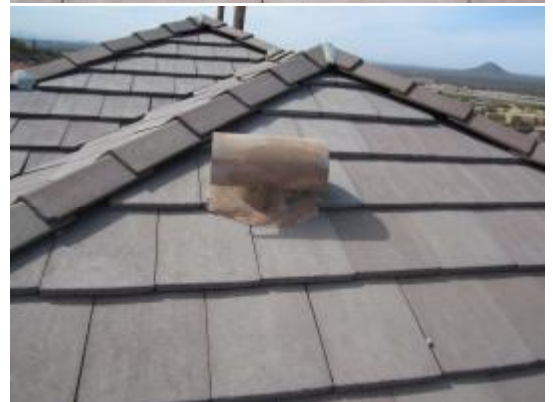
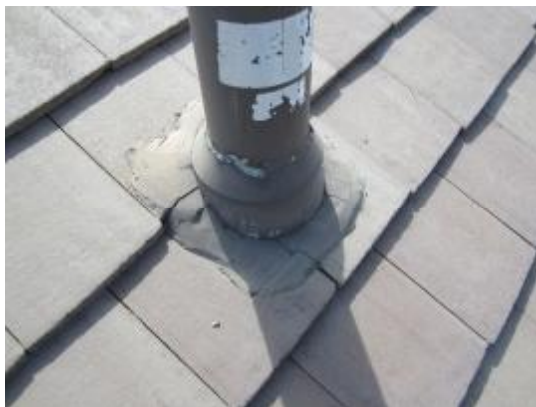
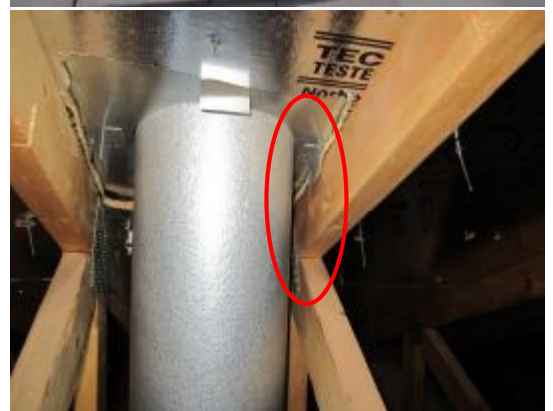
- 4. Repair:** Mortar has been used instead of flashing at two (2) of the openings through the roofing tiles. The installation of this mortar is not considered to be an acceptable flashing installation because it is not effective at keeping storm water runoff from draining under the roofing tiles. Evidence of water penetration was noted inside the attic at the fireplace chimney pipe that is flashed with mortar. The mortar flashings should be removed and replaced with acceptable metal flashings by a qualified licensed roofing contractor.

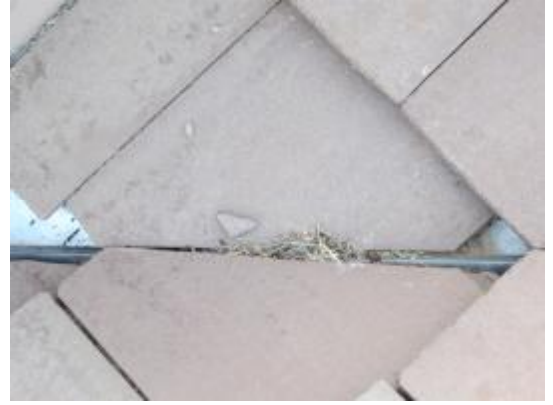
5. **Repair:** The leaves and debris should be removed from the drainage valleys on the roof. The lack of attention could result in water penetration due to the restriction of storm water runoff at the valleys.

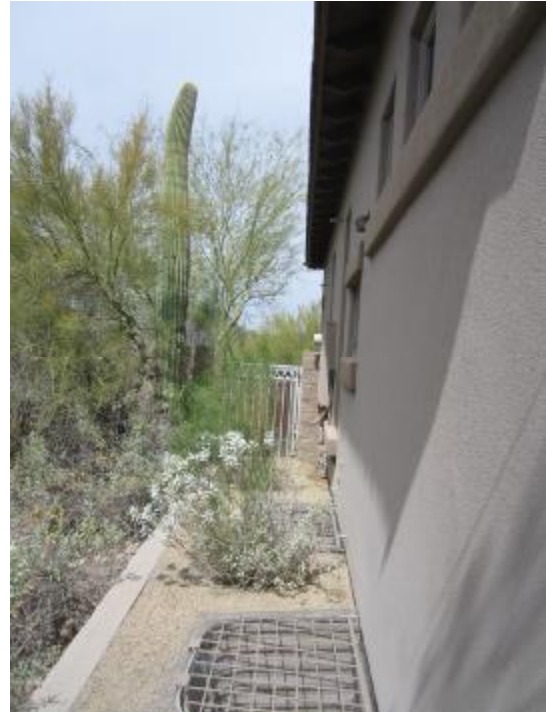
6. **Repair:** Storm water runoff from the roof on the west side of the house falls directly into the basement window wells. The installation of a gutter over this area is recommended.

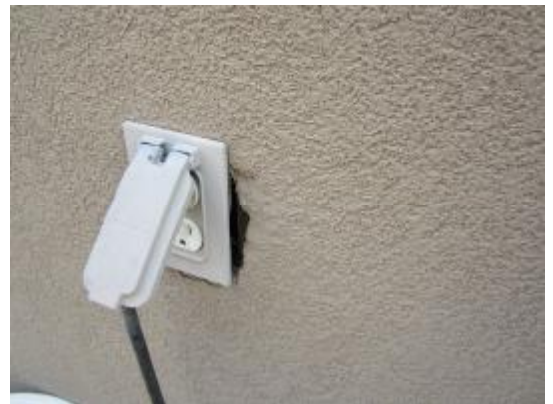
1. **Repair:** The opening in the exterior wall around the electrical outlet on the east wall of the guesthouse should be repaired and sealed in order to prevent damage due to water penetration and vermin infestation.

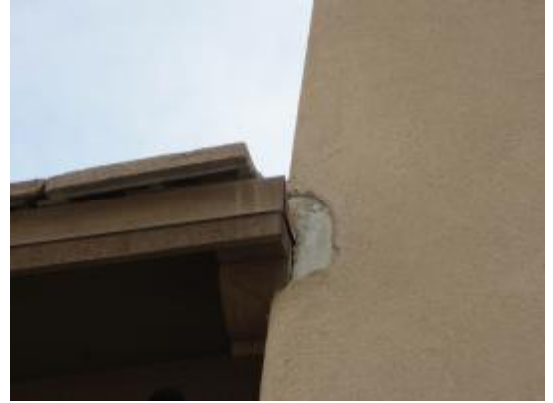
2. **Repair:** The stucco finish coating on the back wall near the roof is chipped. Repair is needed.

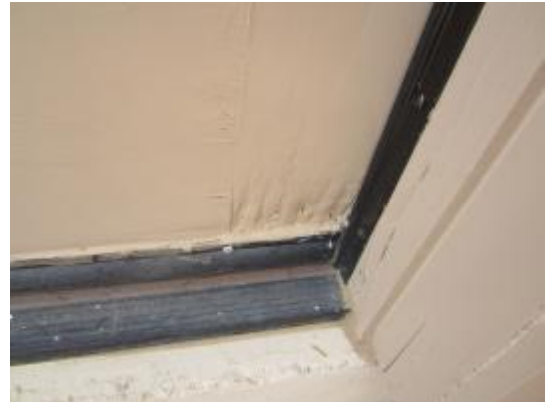
3. **Repair:** The exterior wood doors to the office, laundry room and guesthouse are damaged. Repairs or replacements are needed.

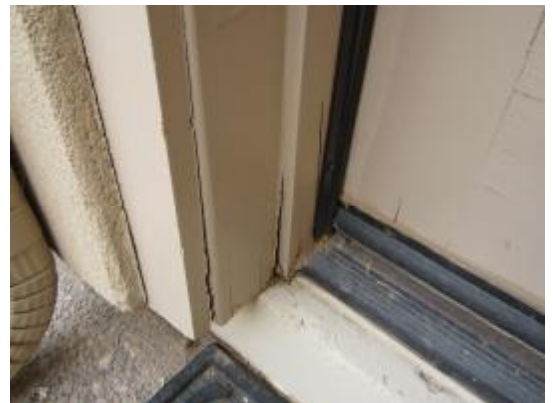
4. **Repair:** The wood doorjamb and casings around the exterior doors to the laundry room, office, master bathroom, water heater closet and guest house should be repaired, caulked and painted in order to prevent additional damage due to water-moisture penetration.

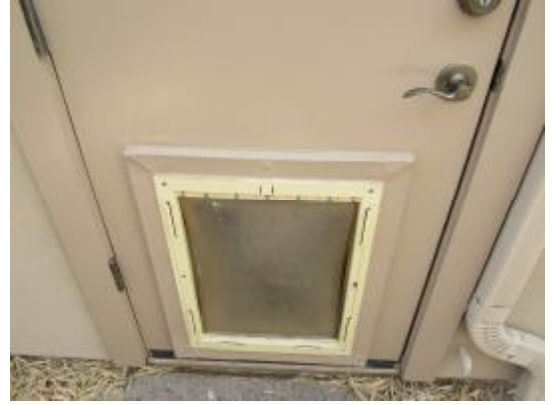
7. **Repair:** The wood trim around the pet door in the exterior door to the water heater closet is damaged due to water penetration. Repair or replacement is needed.

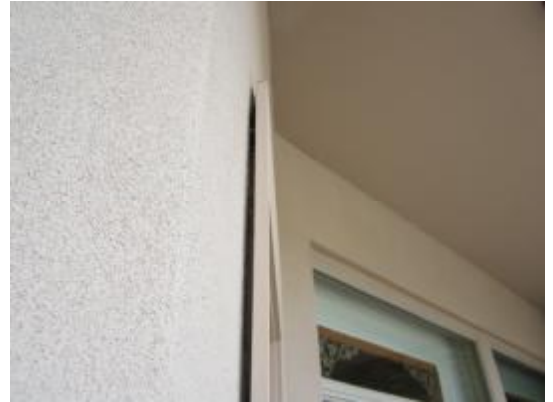
8. **Repair:** The casing around the exterior door to the back patio should be re-secured and sealed to the exterior wall.

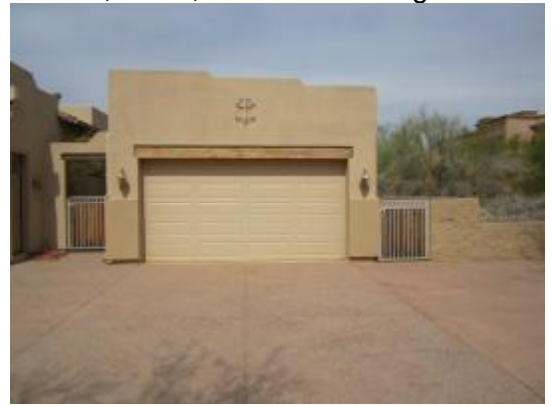
13. **Note:** The overhead garage door for the guesthouse garage has been covered by a drywall wall from the interior.

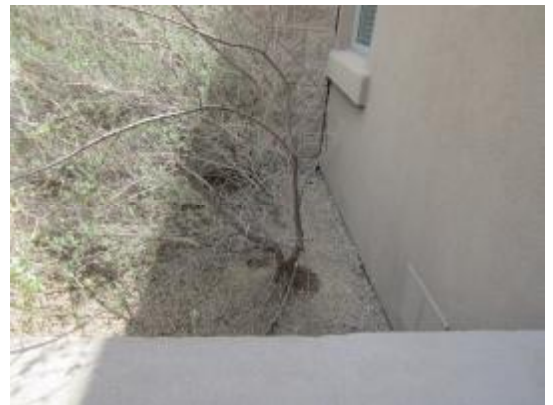
14. **Repair:** The grading in the east side yard near the guesthouse should be improved to promote the flow of storm water away from the foundation. The lack of attention could result in damage due to water-moisture penetration and/or settling concerns.

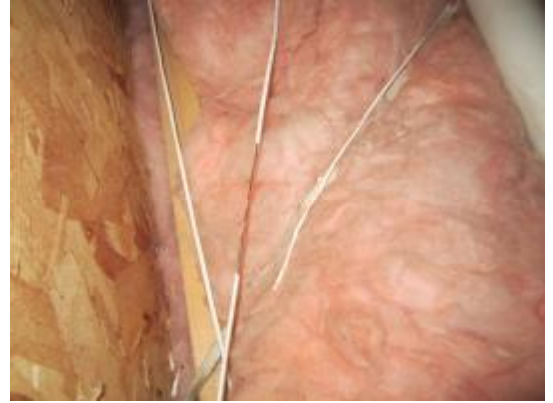
5. **Repair:** One (1) of the low voltage wires for the security system has damaged by rodents inside the attic. Repair and further evaluation is needed.

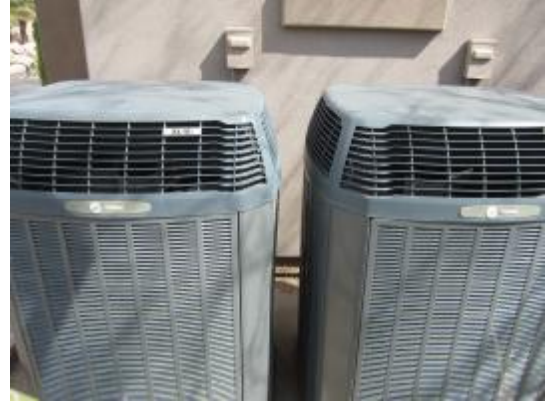
3. **Improve:** The spaces provided between the exterior components of the air conditioning units are less than ideal. The larger the space the more effective these components can be at transferring the heat from inside the house to the exterior. The air conditioning units will still operate; however, they may be less efficient than possible, especially during the hottest days of summer. Check with your air conditioning contractor for additional information.

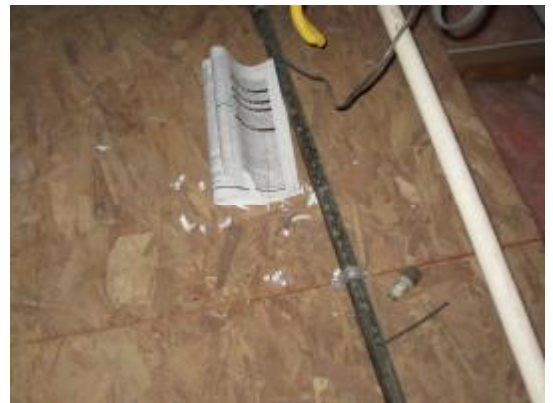
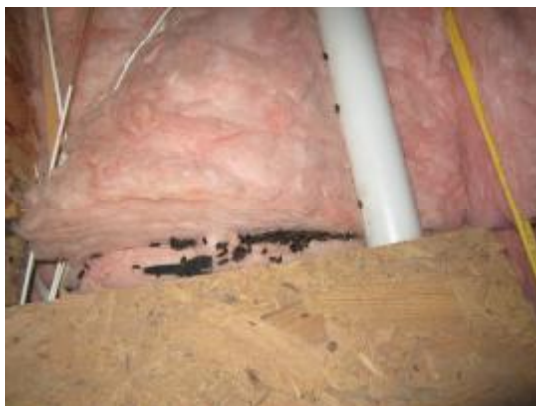
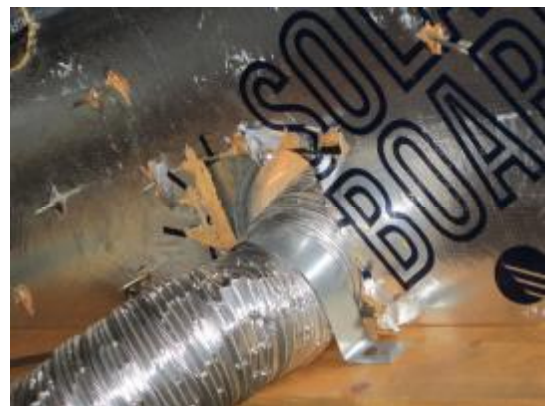
1. **Repair:** There is evidence of vermin activity inside the attic. A qualified pest control specialist should be engaged in order to insure that the attic is vermin free and to protect against future infestation.

Possible point of entry.

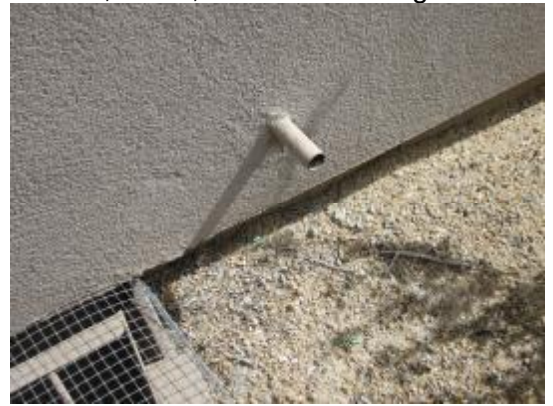
2. **Safety Issue, Repair:** A ninety-degree elbow should be added to the end of the discharge piping serving the Temperature and Pressure Relief (TPR) Valve for the steam generator. This elbow will direct super heated discharge safely straight to the ground.

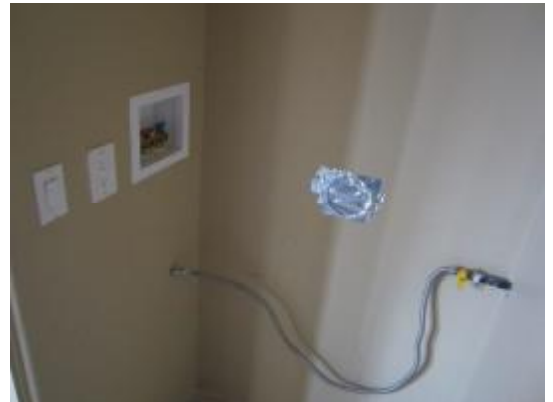
3. **Safety Issue, Repair:** A cap should be installed on the end of the gas supply pipe to the dryer in the guest house when not in use in order to prevent gas leakage into the house.

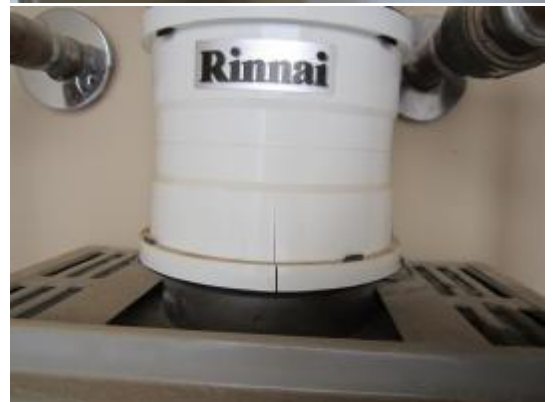
4. **Repair:** The exhaust vent collar above the water heater is cracked. Replacement is needed.

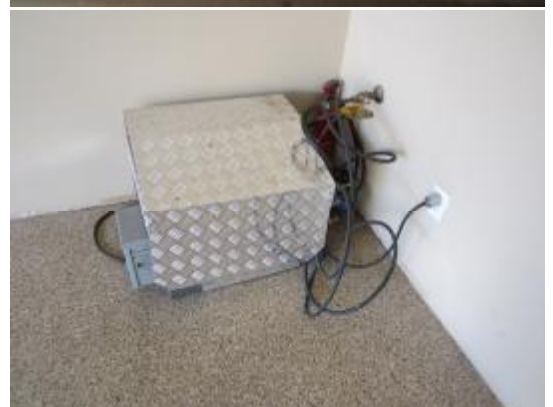
5. **Repair:** The pressure washer is not operational. The water supply and pump were turned on; however, not water was supplied to the nozzle. Repair is needed.

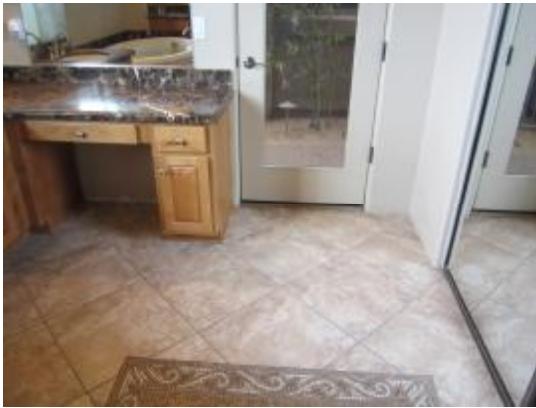
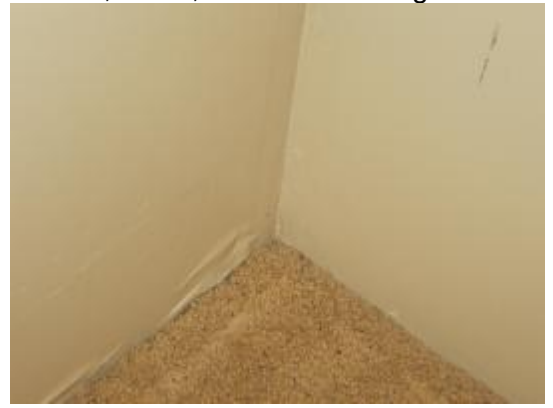
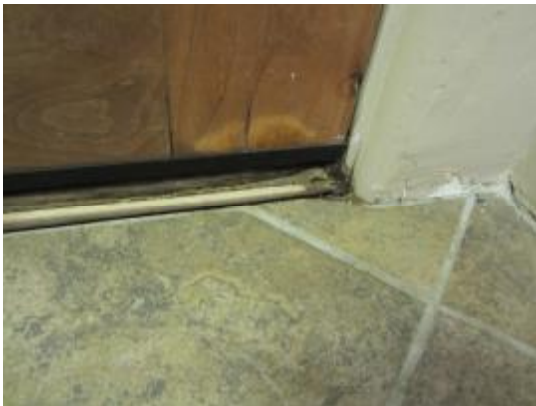
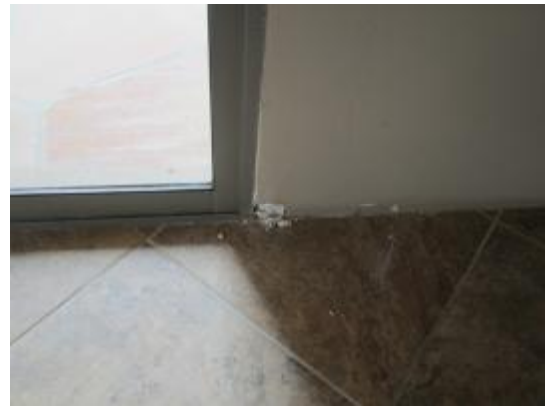
1. **Safety Issue, Repair:** At least one (1) of the windows in the guest house bedroom should open in order to provide egress directly to the exterior.
2. **Repair:** Water damage was noted in the drywall walls next to the exterior doors in the laundry room, office, master bedroom and closet, entry hallway and guest house. A qualified licensed contractor familiar with moisture damage remediation should be engaged in order to make the needed repairs.

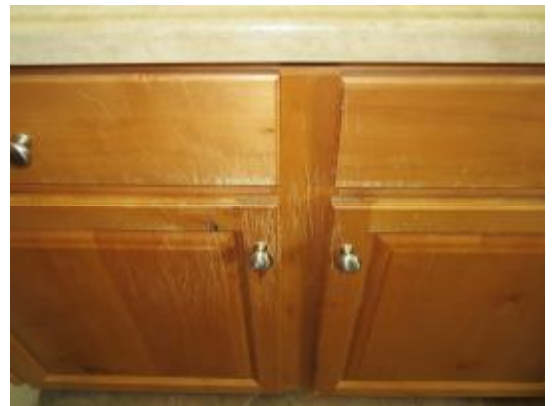
3. **Repair:** The doors to the front corner bedroom do not latch when closed. Adjustment is needed.
4. **Repair:** The doors inside the front corner bedroom and the cabinets in the laundry room are scratched.

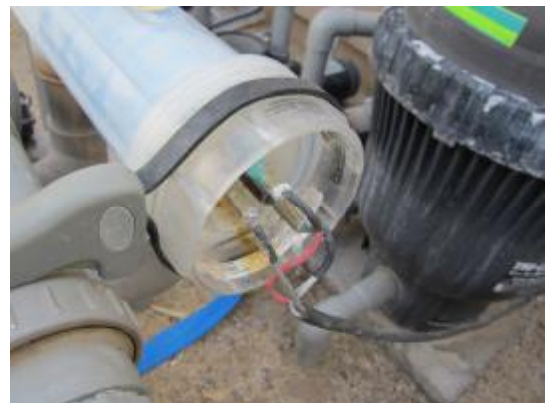
- Repair:** The flow of water through the circulation system is very low. Repair is needed.
- Repair:** The salt water chlorinating system and the in-floor pop-up head self-cleaning system are not operational. This may be due to the low flow of water through the circulation pump. These systems should be further evaluated once the pump has been repaired, and service or repaired as needed.
- Repair:** The container for the plates in the salt water chlorinating system is leaking. Repair is needed.

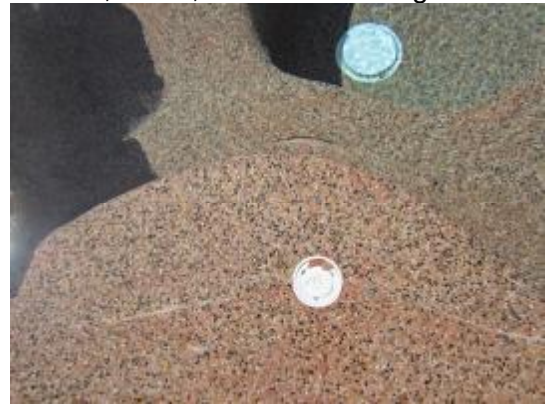
4. **Repair:** The exposed aggregate surface inside the spa is cracked. This is an indication that large sections of the surface material around the cracks have separated from the gunite. The damaged sections of the surface should be removed and replaced.

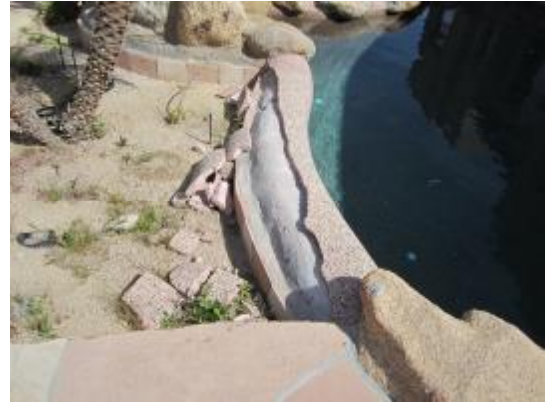
5. **Repair:** The exposed aggregate surface at the rolled edge above the back of the pool is damaged. Repair is needed.
